EVALUATION OF THE DOW 17 TREATMENT
FOR MAGNESIUM ALLOYS

D. Mat Report No. 192

MINISTRY OF DEFENCE (PROCUREMENT EXECUTIVE)

MAGNESIUM ELEKTRON LIMITED

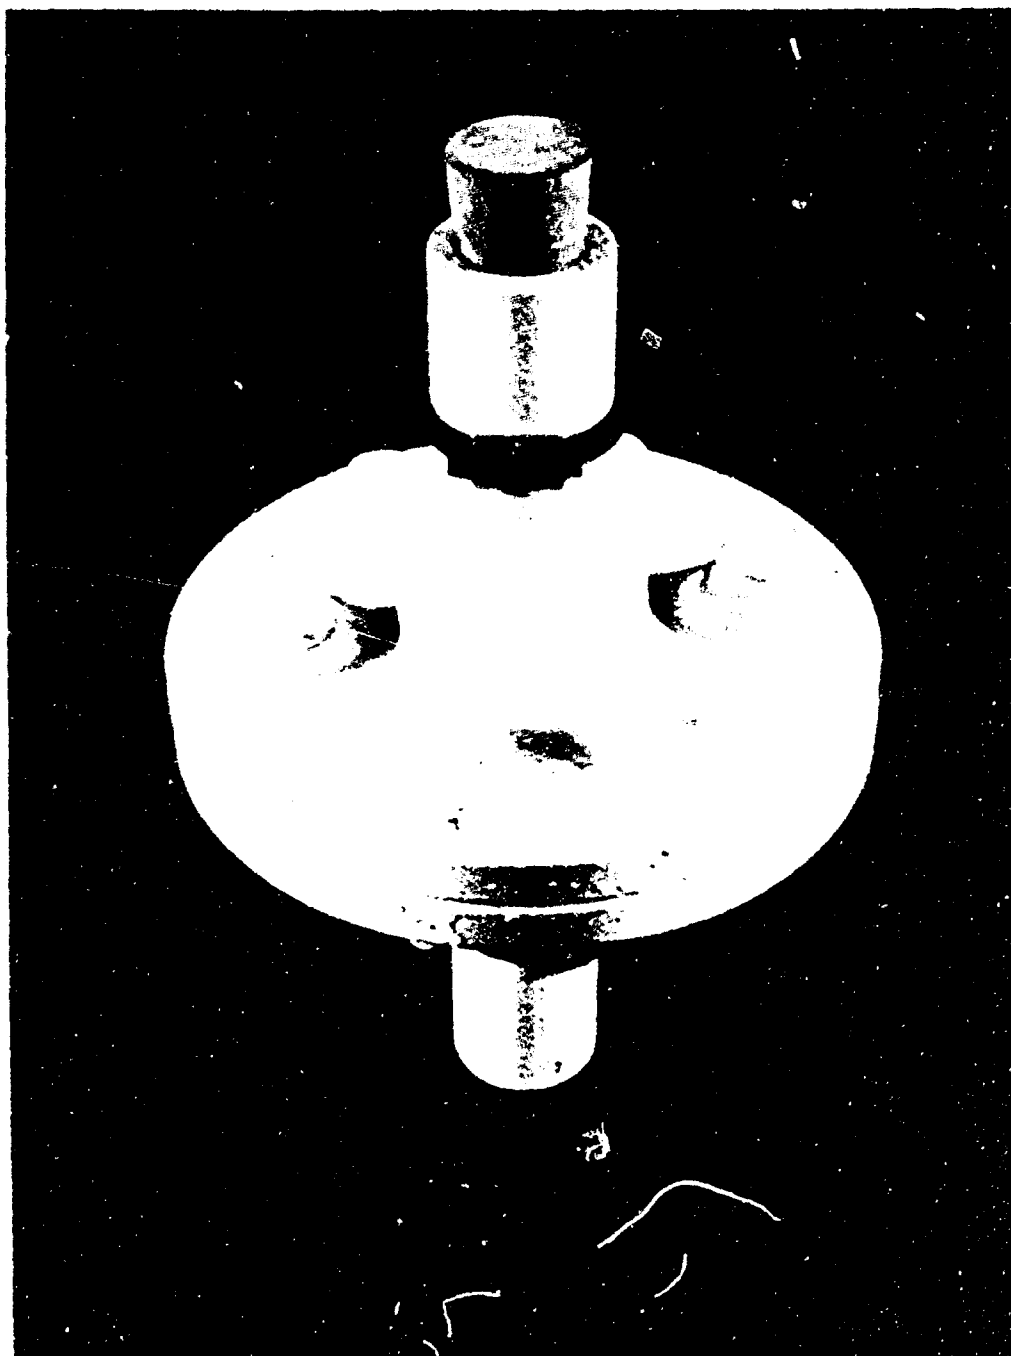
Fig. 4: ZRE1 Flange After 12 months Humidity Test.
Procol Dow 17 + DTD 5389 Paint Scheme. Section 1.5

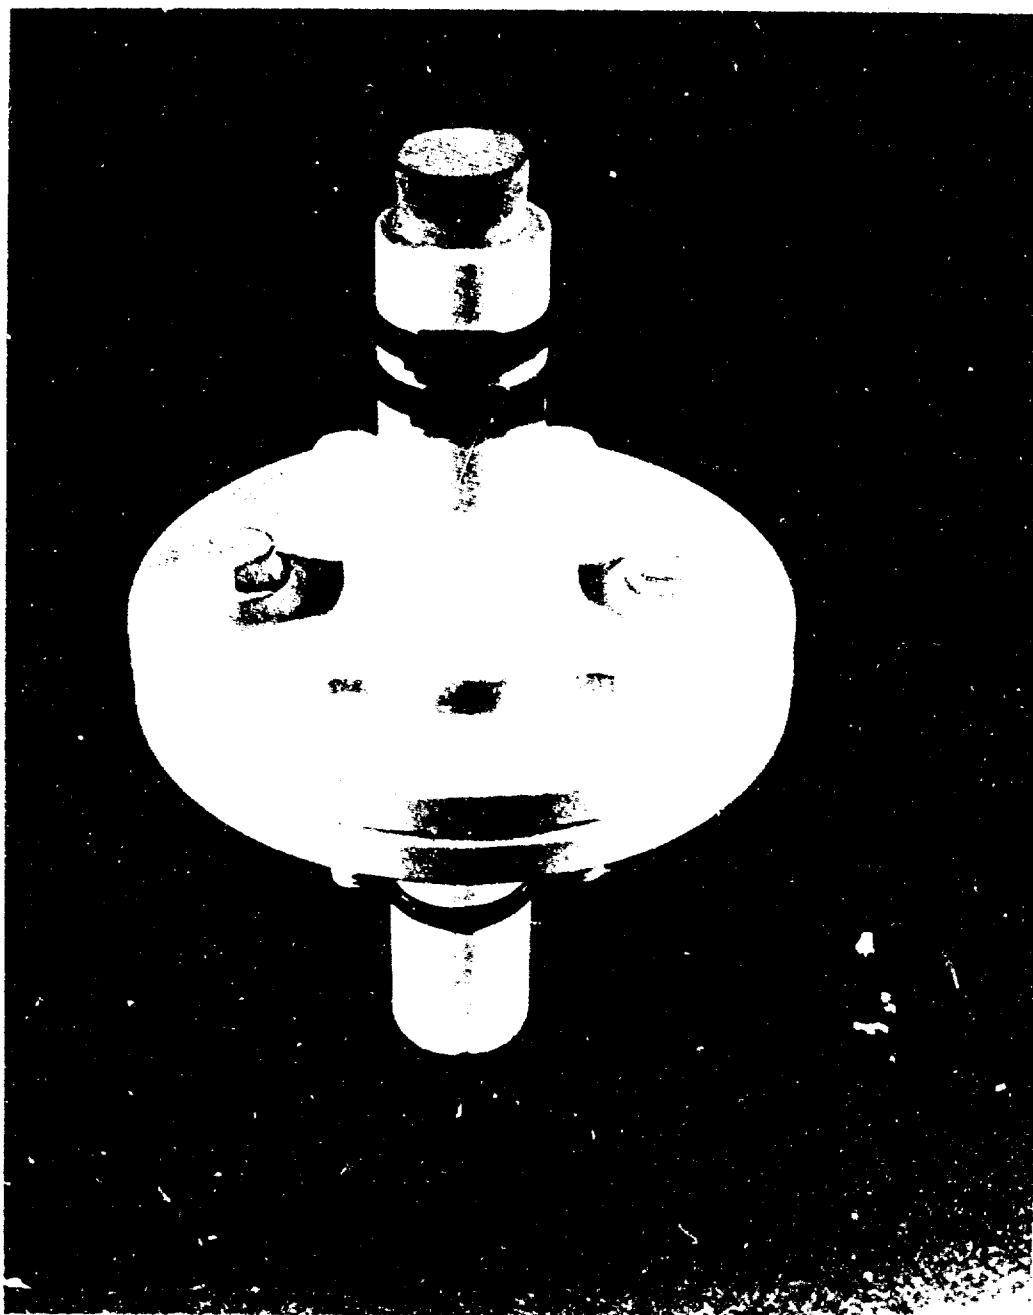
Fig. 5: ZRE1 Flange After 12 Months Humidity Test.
Procol Dow 17 + Surface Sealing + DTD 5580 Paint Scheme
Section 4.3.

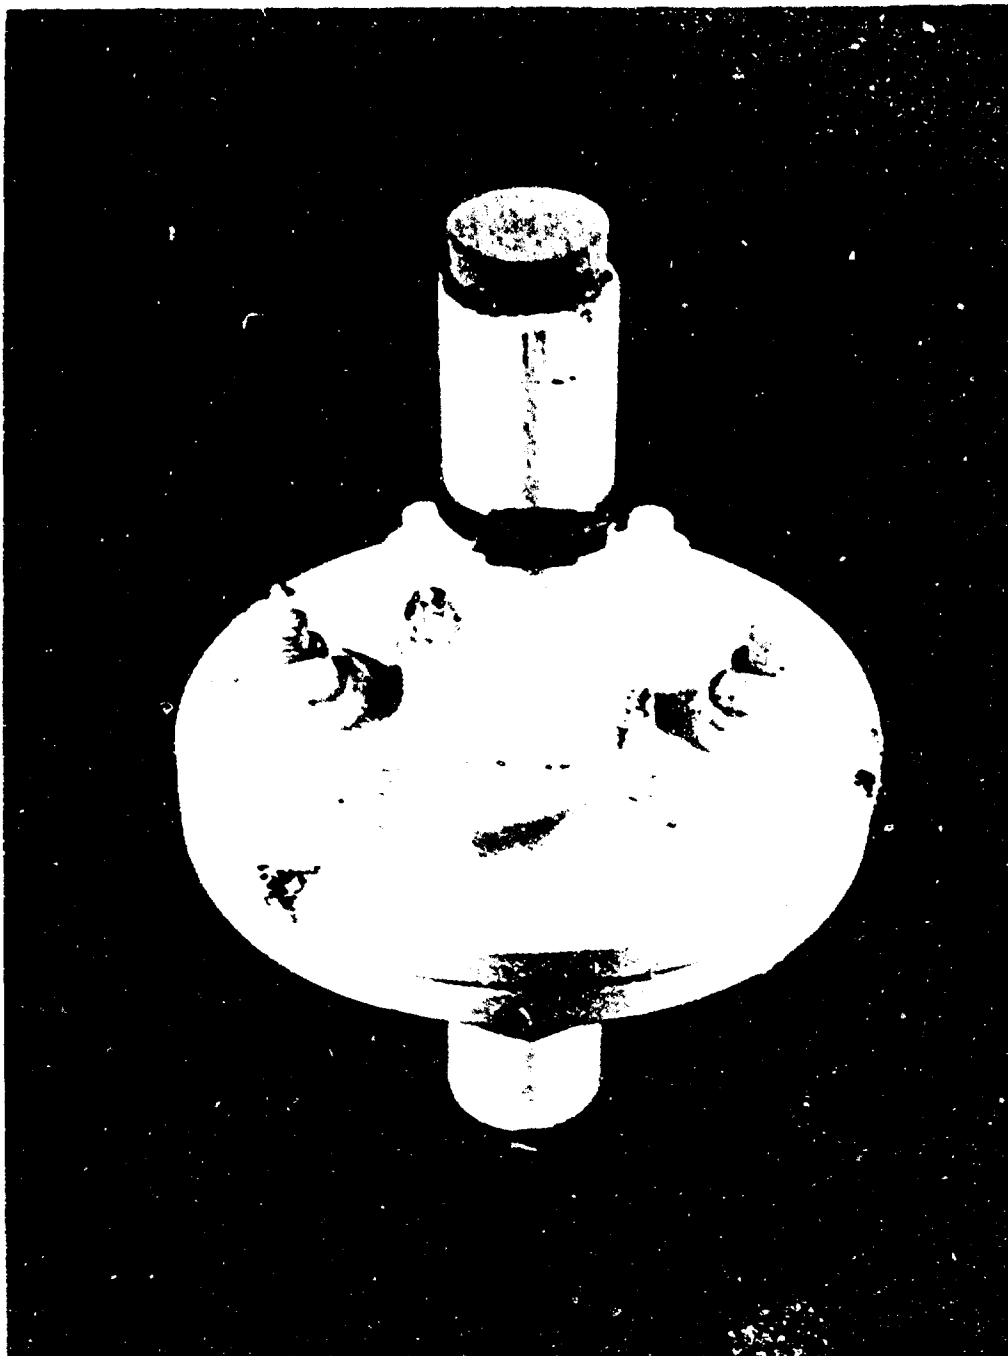
Table 7 summarises the results of 12 months exposure. A corrosion rating has again been given. Severe corrosion breakdowns occurred on all assemblies which had not been surface sealed. The largest and most numerous breakdowns occurred on flanges with the very thin Procol Dow 17 pretreatment (Fig. 6) and became less severe with increasing thickness of Dow 17 film. No significant breakdown occurred on any flange assemblies which had been surface sealed, although single isolated points of breakdown were observed on the assemblies with 0.15 (Fig. 7) and 0.8 mil Dow 17 coatings. 1.5 mil Dow 17, H.A.E. and DTD 911C pretreatments with DTD 5580 top coats all showed no breakdown.

Fig. 6: 38 Flange After 12 Months R.A.L. Test.
Protocol low 17 - DTD 5589 Paint Scheme. Section 4.3

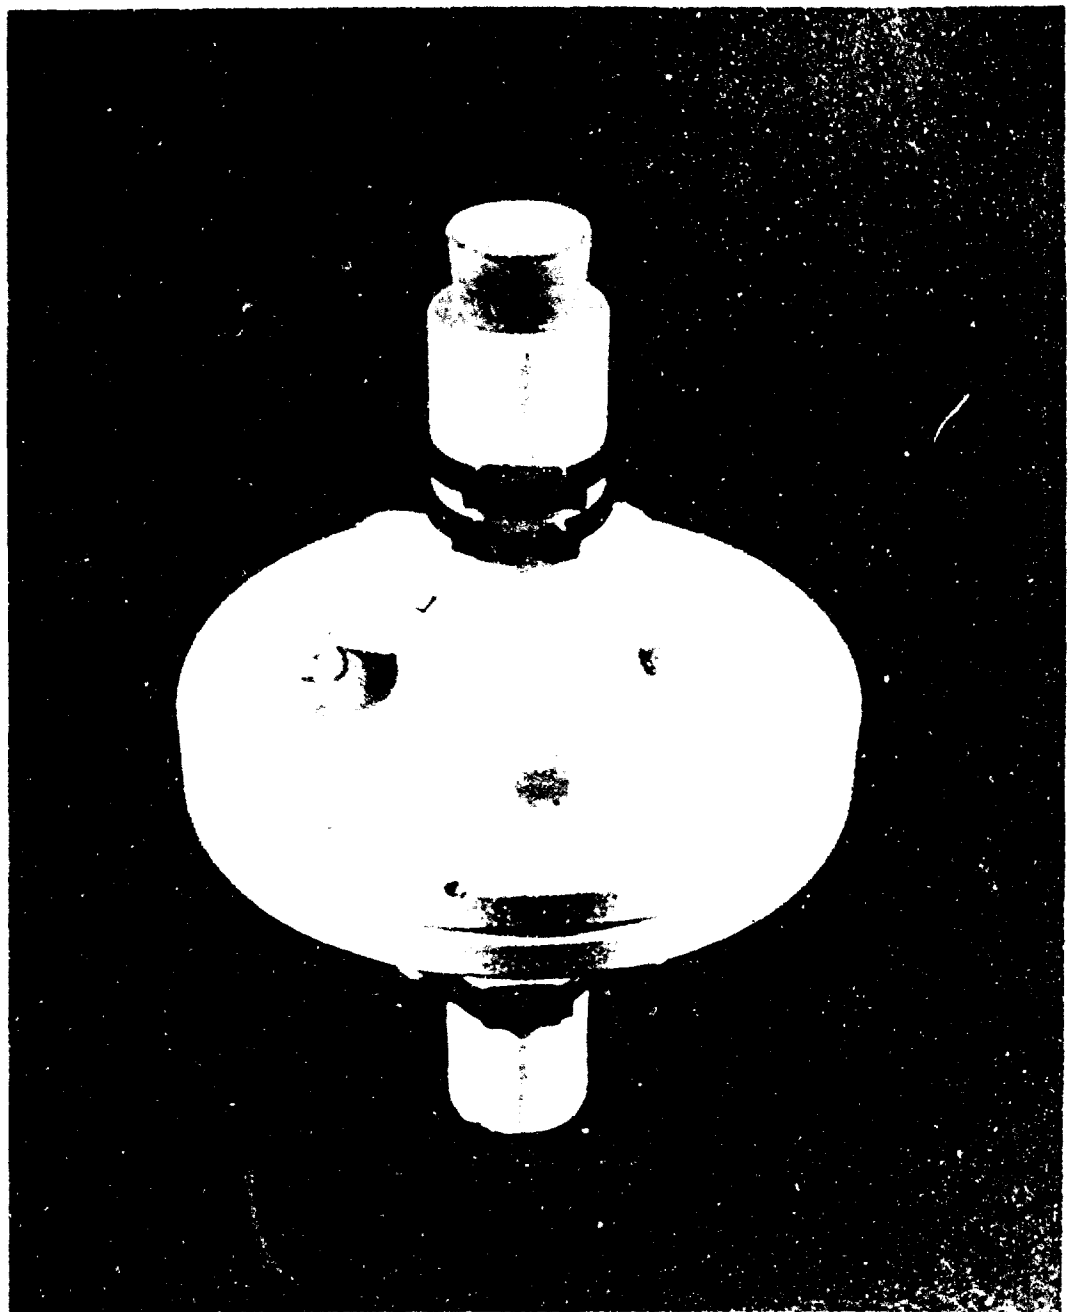
Fig. 7: ZRE1 Flange After 12 Months R.A.E. Test.
Procel pow 17 - Surface Sealing - DTD 5580 Print Scheme.
Showing Isolated Breakdown. Section 4.3
